FINAL REPORT

February 2002

Seismic Rehabilitation Alternatives for the Ahwahnee Hotel Yosemite National Park, California

Indefinite Quantity Contract No. I443CX2000-97-028
NPS Seismic Safety Program (2001-A250-405)

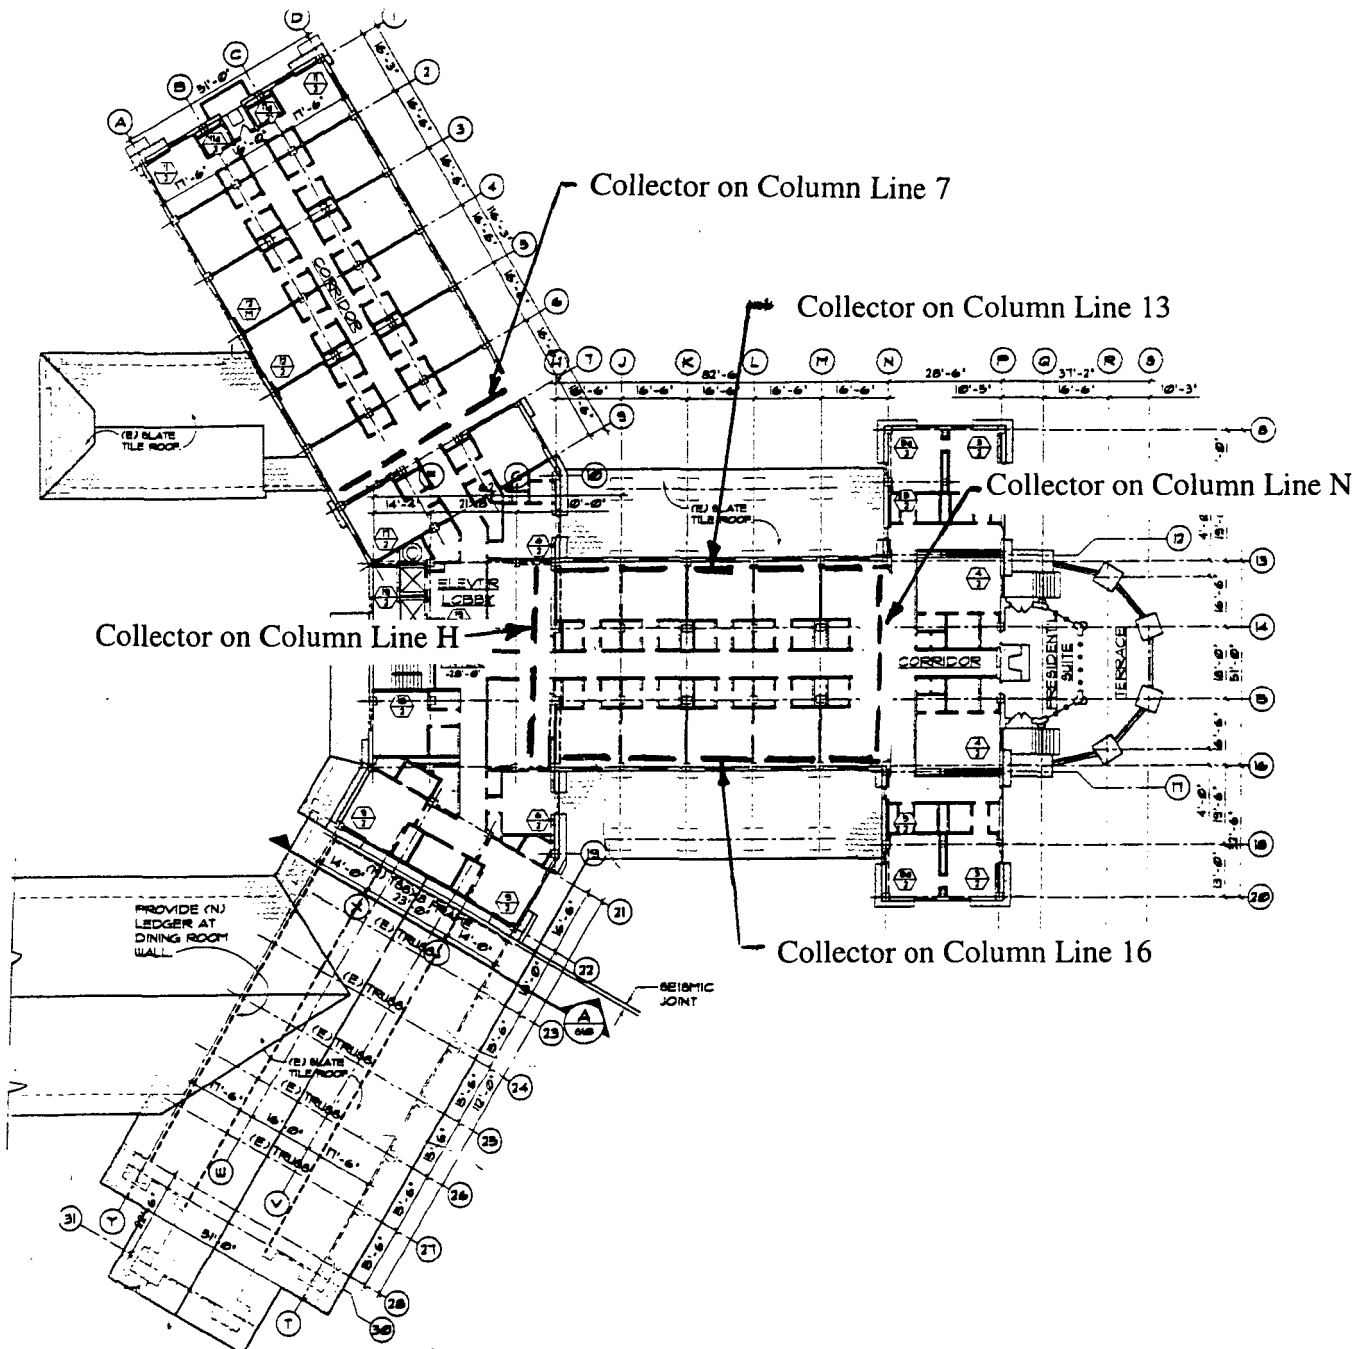
Figure 3.1 Location of Second Floor Collectors

The ultimate capacity of each of collector is limited to the weakest beam/column connection along the length of the collector. The ultimate capacity of the second floor collectors on Column lines 13 and 16 is approximately 80 kips based on the tensile capacity of the riveted beam/column connections. Similarly, the ultimate capacity for the second floor collectors on column line 7 as well as the collectors on column lines H and N is approximately 40 kips each. The ultimate capacity is the same for both the Life Safety and Limited Damage evaluations.

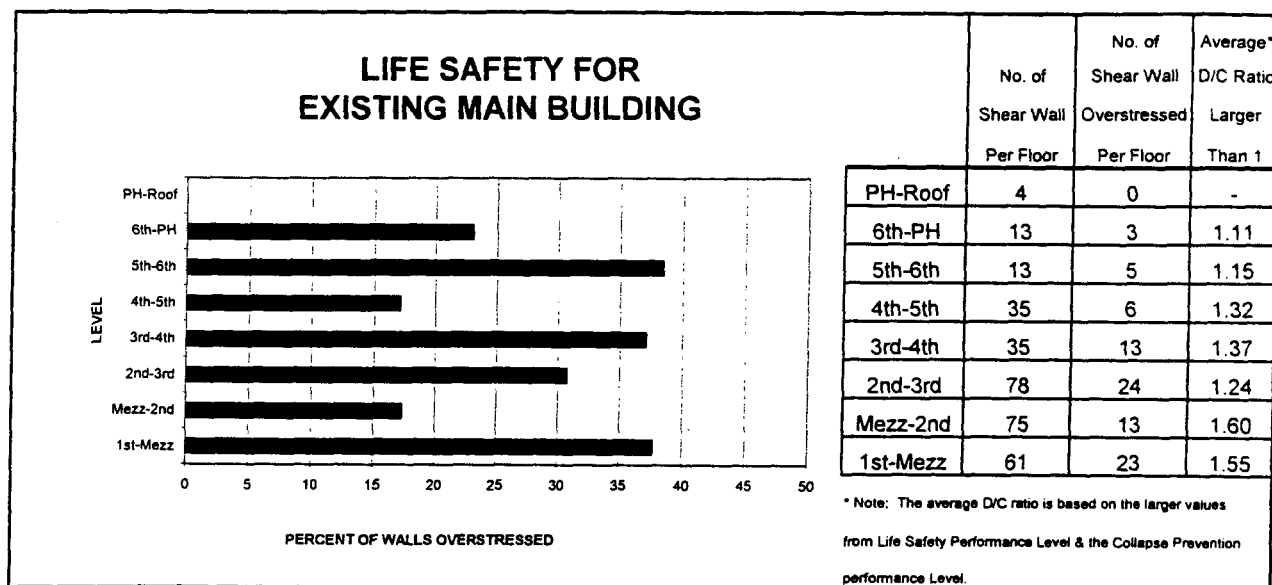
See Figures 3.2 and 3.3 for the results of the evaluation for both the Life Safety and Limited Damage Performance Levels.

**FIGURE 3.2 LIFE SAFETY PERFORMANCE LEVEL
EVALUATION RESULTS OF SHEAR WALLS IN EXISTING MAIN BUILDING**

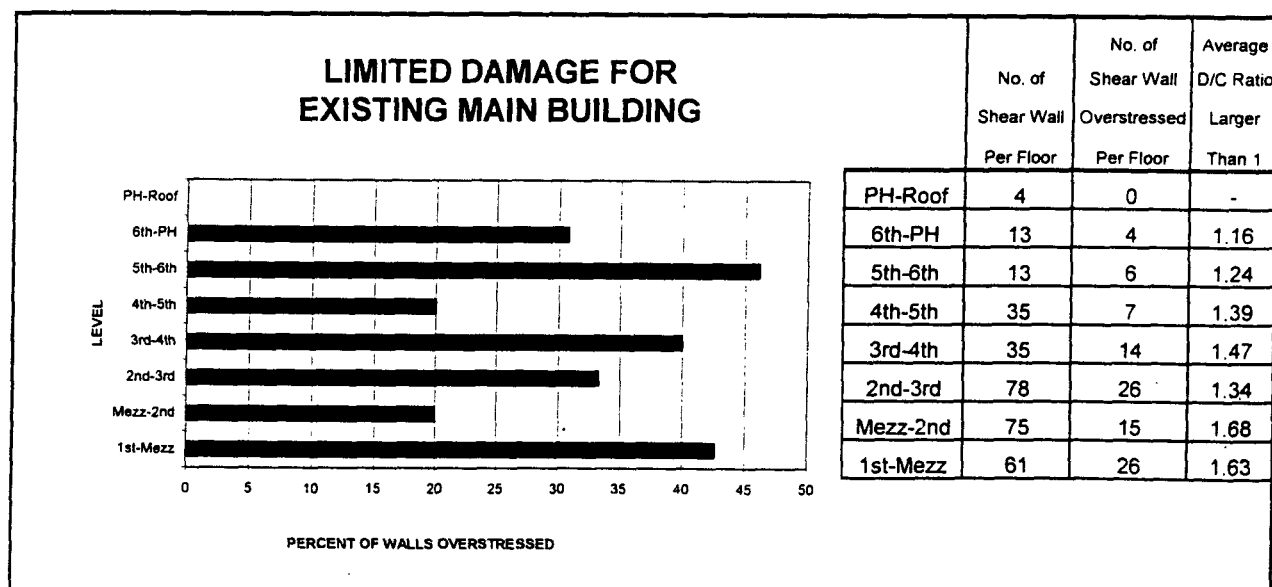
**FIGURE 3.3 LIMITED DAMAGE PERFORMANCE LEVEL
EVALUATION RESULTS OF SHEAR WALLS IN EXISTING MAIN BUILDING**

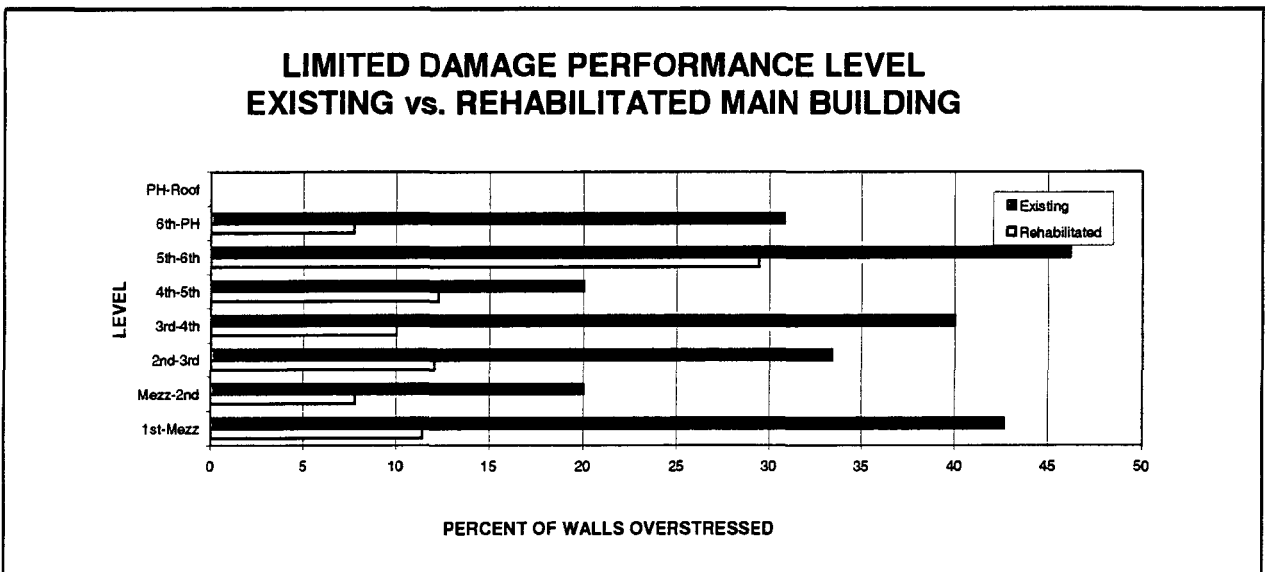
**FIGURE 4.2 LIMITED DAMAGE PERFORMANCE LEVEL- (EXISTING vs. REHABILITATED)
EVALUATION RESULTS OF SHEAR WALLS IN MAIN BUILDING**

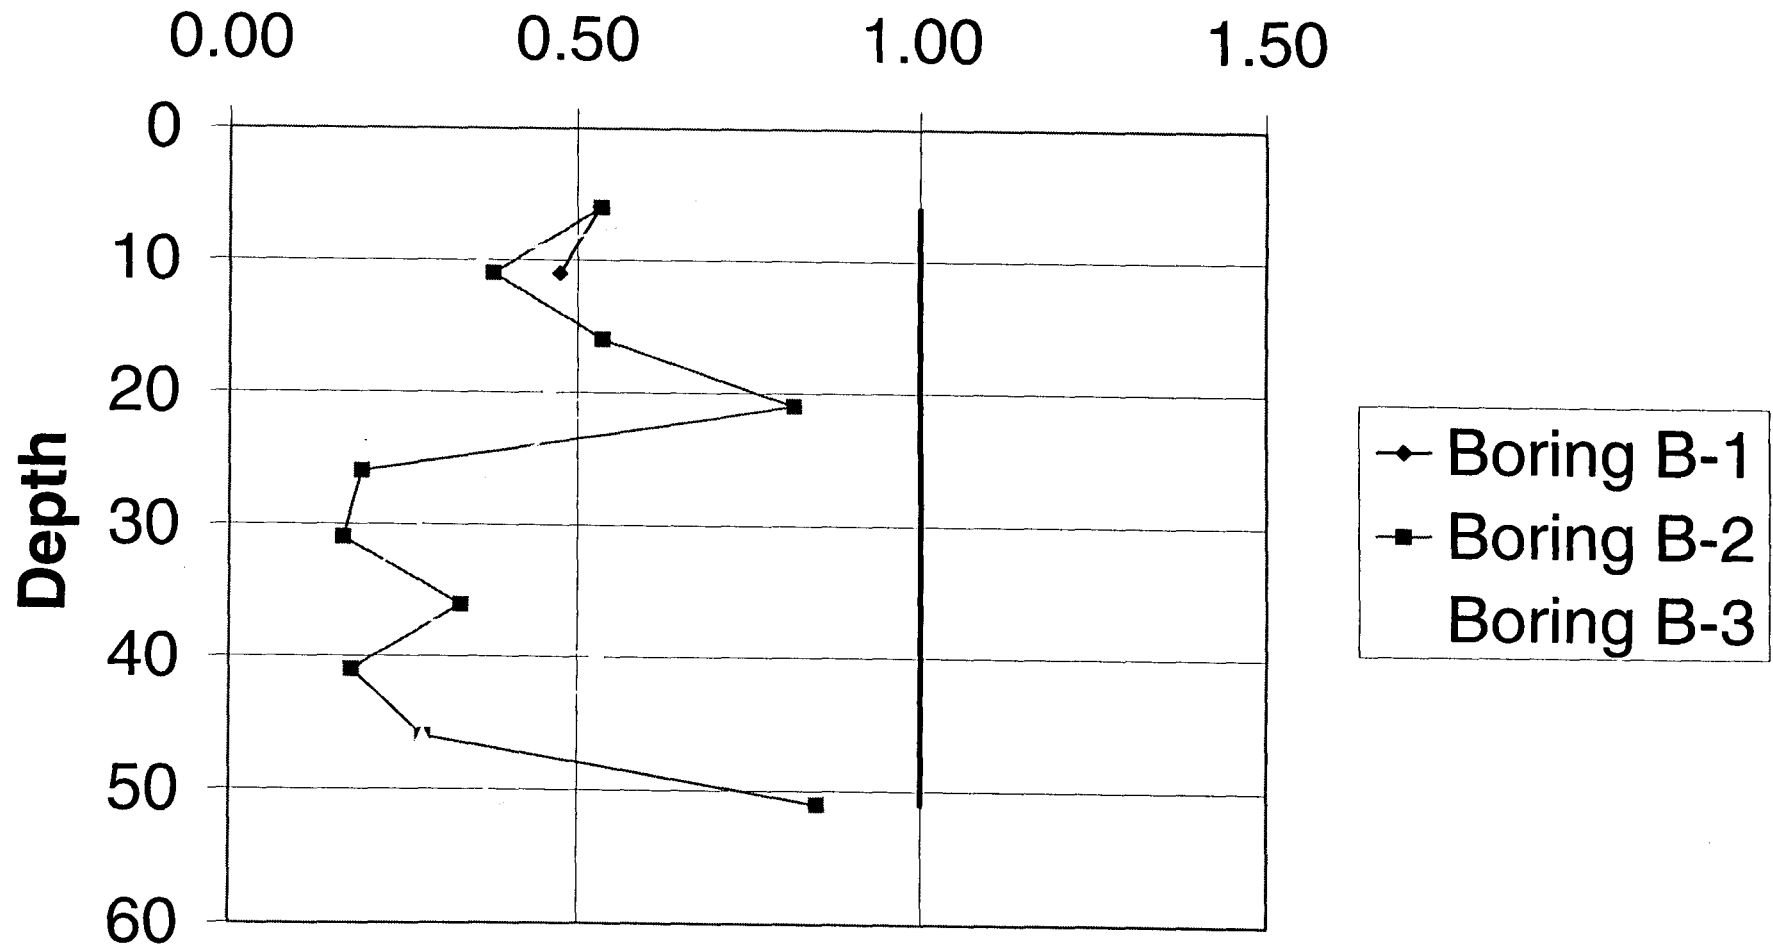
Liquefaction Safety Factor

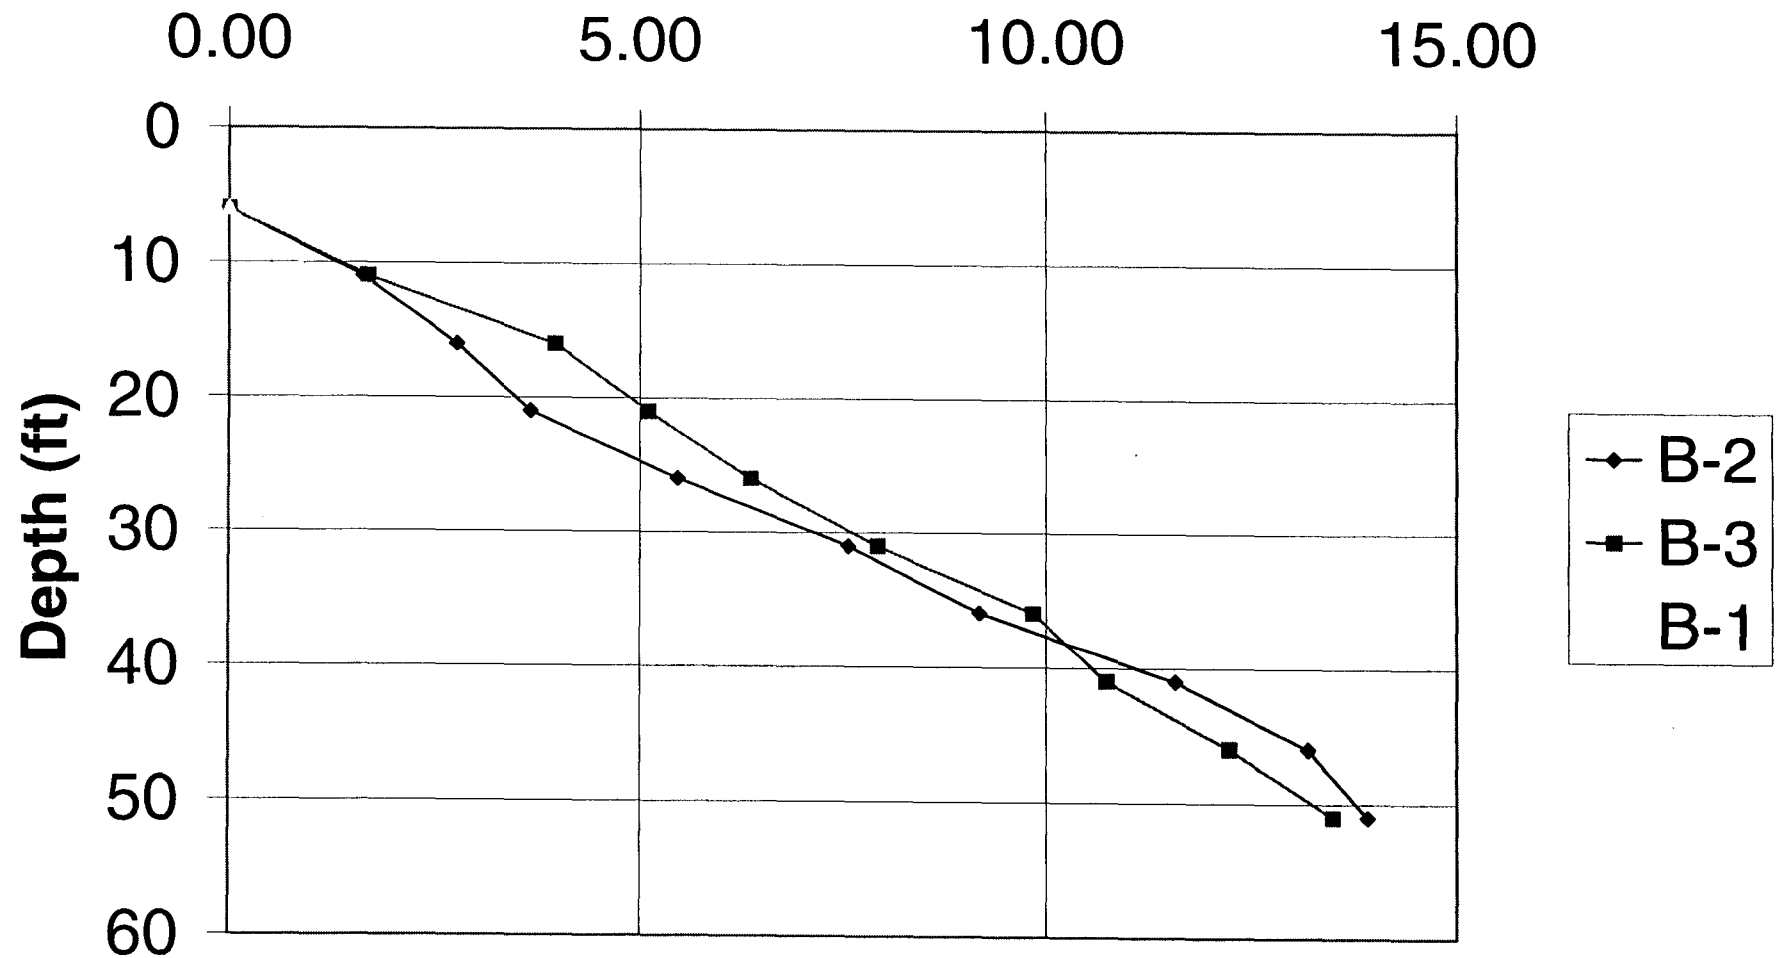
M=7.5, PGA = 0.39g
Cumulative Settlement (in.)
